Panel Prop Failure

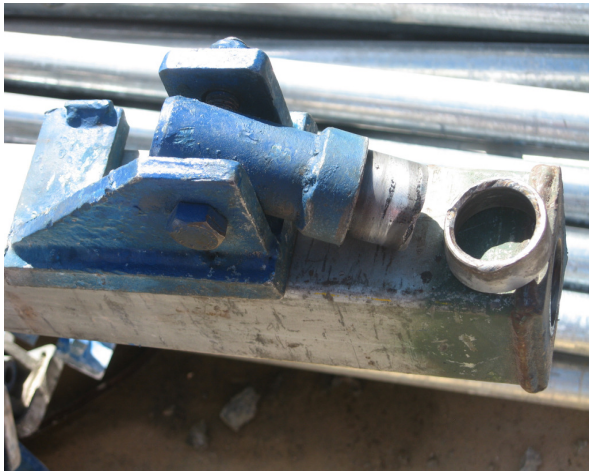
Recently on a CBD site a rigger was in the process of removing props from pre cast panels positioned several weeks earlier, when the prop foot became detached from one of the props he was removing. Fortunately the foot remained inside the site. The riggers then stripped the prop down to reveal that the weld had failed on the collar that insured the foot stayed secured in the brace section. Unfortunately where this prop failed could not be visually inspected as it positioned inside brace section. *See photos below.*

View of failure of weld on prop foot

Temporary bracing props shall be regularly maintained and inspected between each use to ensure that all components are correct and in good working order.

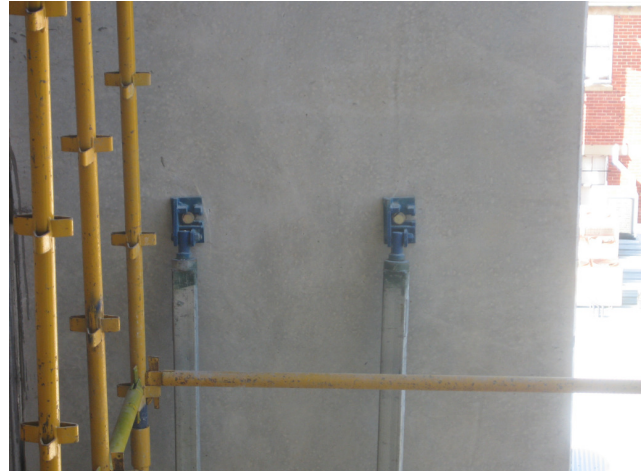
View of Prop foot attached to concrete panel

Prop feet or shoes must be the type that physically prevents lateral displacement of the shoe from the insert connections after installation.
